**DEPARTMENT OF TRANSPORTATION**

Contract #: 04-0120F4Cty: SF/ALA Rte: 80 PM: 13.2/13.9File #: 69.28**WELDING INSPECTION REPORT****Resident Engineer:**Siegenthaler, Peter**Address:** 333 Burma Road**City:** Oakland, CA 94607**Report No:** WIR-019091**Date Inspected:** 08-Jan-2011**Project Name:** SAS Superstructure**OSM Arrival Time:** 700**Prime Contractor:** American Bridge/Fluor Enterprises, a JV**OSM Departure Time:** 1900**Contractor:** Zhenhua Port Machinery Company, Ltd (ZPMC), Changxing Island **Location:** Shanghai,China**CWI Name:** Cheng Xi**CWI Present:** Yes No**Inspected CWI report:** Yes No N/A**Rod Oven in Use:** Yes No N/A**Electrode to specification:** Yes No N/A**Weld Procedures Followed:** Yes No N/A**Qualified Welders:** Yes No N/A**Verified Joint Fit-up:** Yes No N/A**Approved Drawings:** Yes No N/A**Approved WPS:** Yes No N/A**Delayed / Cancelled:** Yes No N/A**Bridge No:** 34-0006**Component:** OBG**Summary of Items Observed:**

## WELDING INSPECTION REPORT

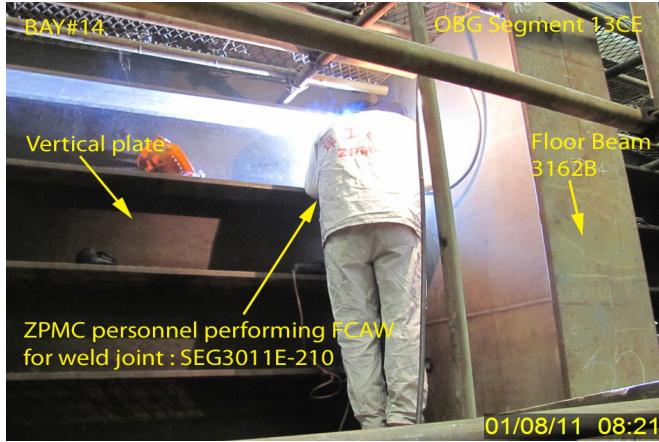
FCAW in the 3G position for the OBG Segment 13CE Floor Beam to Vertical plate. The weld joint was designated as: SEG3011E-210. The welder is identified as #066041. ZPMC QC is identified as Mr. Zhong yong hong. The welding variables recorded by QC appear to comply with WPS-B-T-2233-ESAB. Please see the attached picture.

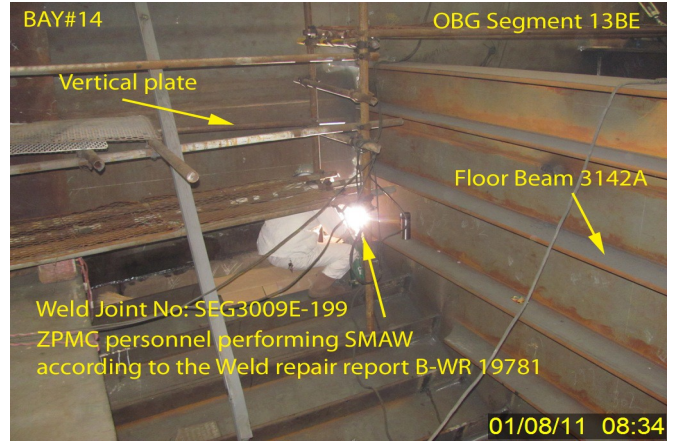
SMAW welding of weld joint no: SEG3009E-199 located on OBG Segment 13BE Vertical plate to Floor beam. Welder is identified as #066258. ZPMC CWI is identified as Mr. Cheng Xi. Welding was performed according to the weld repair report B-WR19781. The welding variables recorded by QC appeared to comply with the WPS-345-SMAW-3G(3F)-FCM-Repair-1. Please see the attached picture.
